## GEOMETRY AND LEANING OF ALHADBA MINARET

*There is great effort of planning to rebuild the recently destructed Alhadba minaret in Mosul. A major requirement is to study the original shape and materials. During the past years, there was a considerable amount of leaning in the minaret due to various natural and human causes. The amount of leaning was generally increasing, but there was no unified or fixed control that is referenced from various monitoring groups. This paper describes the effort that was performed to design and implement a monitoring system that can be referred. Fixed control points and targets have been worked. Samples of monitoring results are presented. Data can be used for reconstruction.*

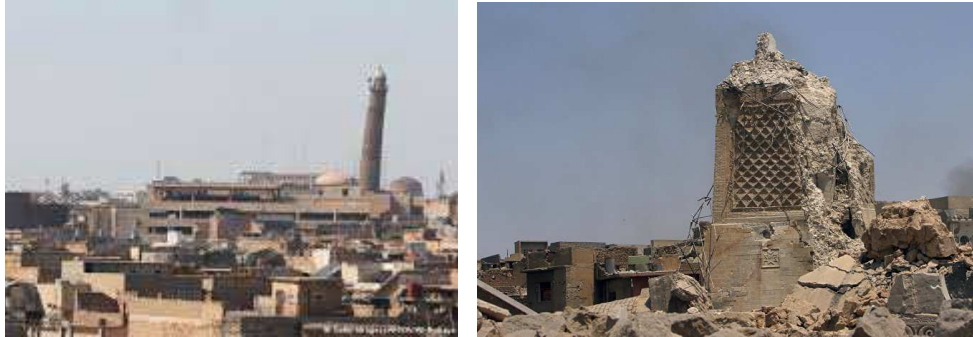
**Figure 1: Alhadba, a Focus Area within the Old City of Mosul Before and After Destruction**

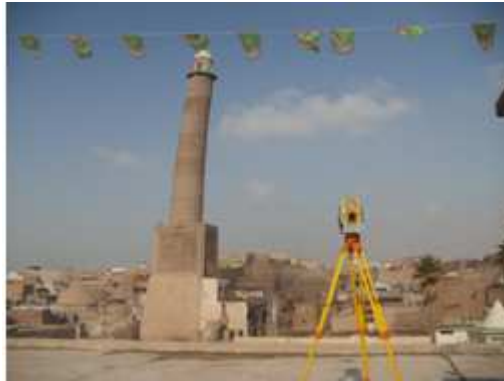
**Figure 2: Topcon Imaging Station at Monitoring Work**

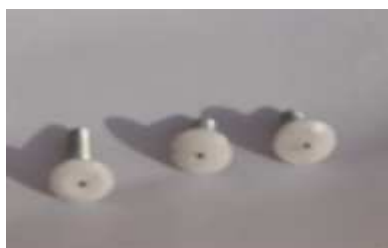
Targets are made of steel bolts of 2 cm head diameter worked using turning machine. The head was rounded and a small hole mark of 1 mm diameter was drilled in the head center representing the exact monitored mark. Bolts are white painted. See figure 4. A high crane was used in fixing these targets and great care was taken in order not to hit the minaret surface or make any destruction as seen in figure 5. A bore hole of about 4 cm deep was drilled into the wall of the minaret, cleaned with brush and filled with adhesive. Finally, the steel bolt pressed into place.

**Figure 4: Steel Bolts Prepared as Targets**

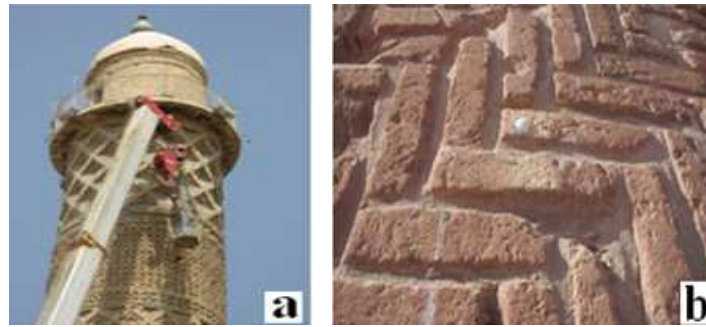
Figure 5: a) Fixing Target Points b) Target Point Ready for Monitoring
